<p>California Public Utilities Commission <i>Mitigation Monitoring, Compliance, and Reporting Program</i></p>
	<p>East County (ECO) Substation Project</p> <p>Compliance Status Report: 026</p> <p>March 30, 2014</p>

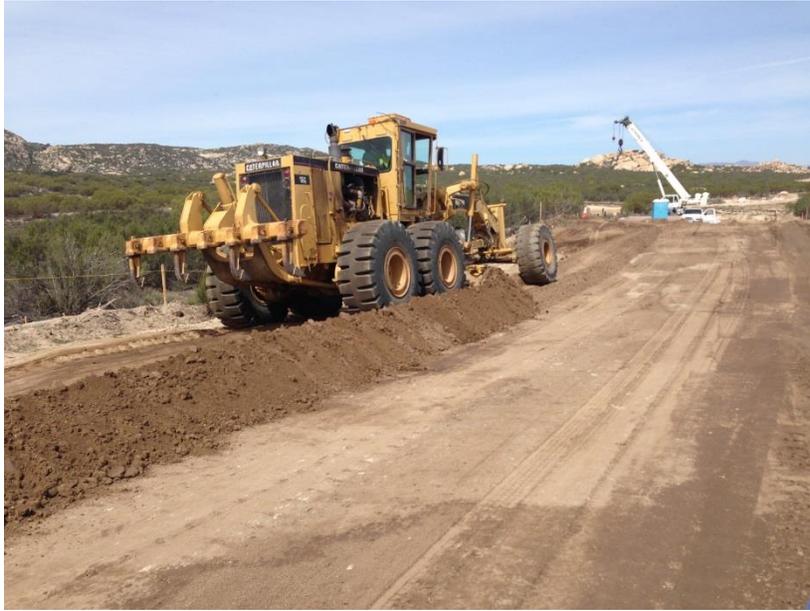
138 kV underground alignment (see Photo 1 – Attachment A), vault placement and completing jack-and-bore activities.

Photo 1: A scraper is utilized to backfill along the 138 kV underground alignment near the Boulevard Substation rebuild.

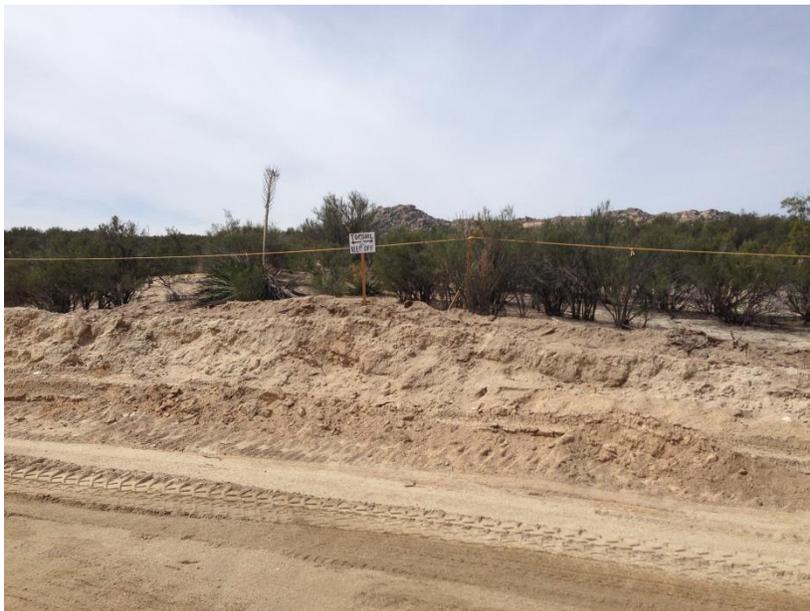
In accordance with MM-BIO-1c, biological monitors were onsite to survey areas of active construction for compliance with biological mitigation measures. Topsoil was observed staged along the limits of work that will be utilized for restoration activities in accordance with MM-BIO-1d (see Photo 1 – Attachment A). Containment bins were observed being placed beneath equipment staged along the right-of-way in accordance with MM-HAZ-1c.

Photo 2: In accordance with MM-BIO-1d, topsoil located in areas to be restored along the 138 kV underground alignment is stockpiled during the excavation process.

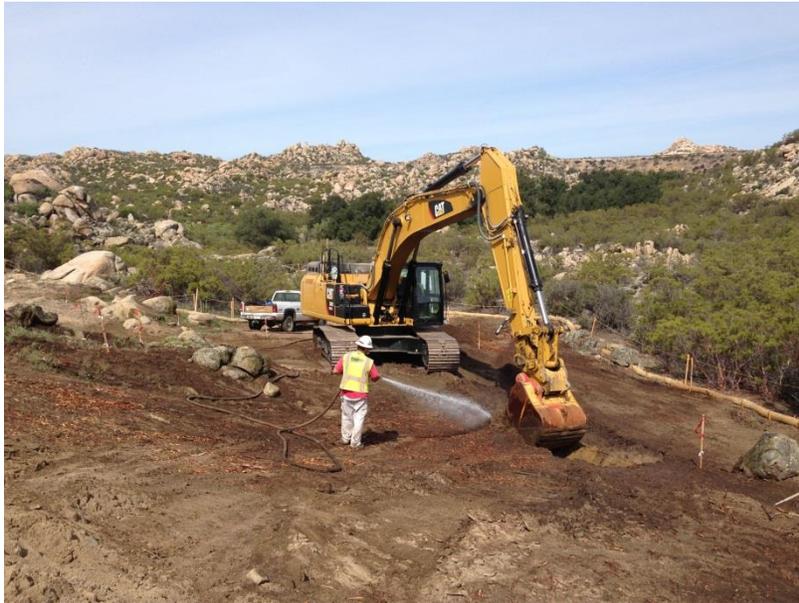
Dust control measures consisting of watering areas of active construction (see Photo 3 – Attachment A), maintaining rattle plates and rock aprons at points of ingress/egress, maintaining speed limits of 15 MPH or less, and cleaning public streets of trac-out were being implemented during this reporting period.

Photo 3: In accordance with MM-BIO-4a, water is utilized to minimize fugitive dust emissions during excavation activities.

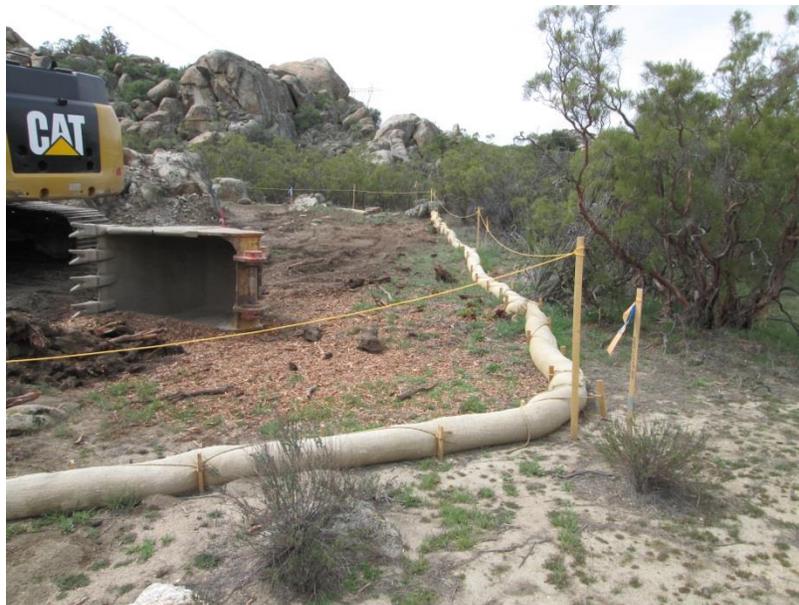
Erosion control measures consisting of straw wattles, silt fence and gravel bags are being maintained along the ROW in accordance with the SWPPP and MM-HYD-1 (see Photo 4 – Attachment A). Erosion control measures have been put in place to reduce the potential for soils located within the approved work limits to be discharged offsite during a rain event.

Photo 4: In accordance with MM-HYD-1, straw-wattles are installed along the perimeter of the work area to minimize the potential for sediment to be discharged beyond the work limits.

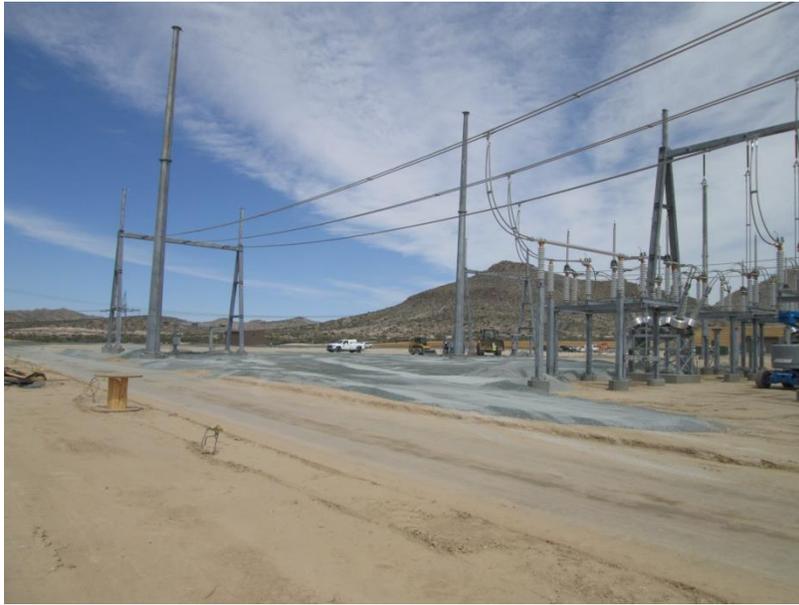
Water trucks were being utilized on a routine basis when crews were observed drilling pier foundations, pouring concrete, erecting H-frame and A-frame structures and when placing Class II fill (see Photo 5 – Attachment A). Speed limit signs have been posted along the main access road reminding all crews to maintain speed limits of 15 MPH or less. A rock apron and rattle plate was also observed being maintained at the primary point of ingress/egress along Old Highway 80 to minimize the potential for trac-out and associated fugitive dust emissions (see Photo 6 – Attachment A).

Photo 5: Class-II fill is placed as the final road base within the limits of the ECO substation.

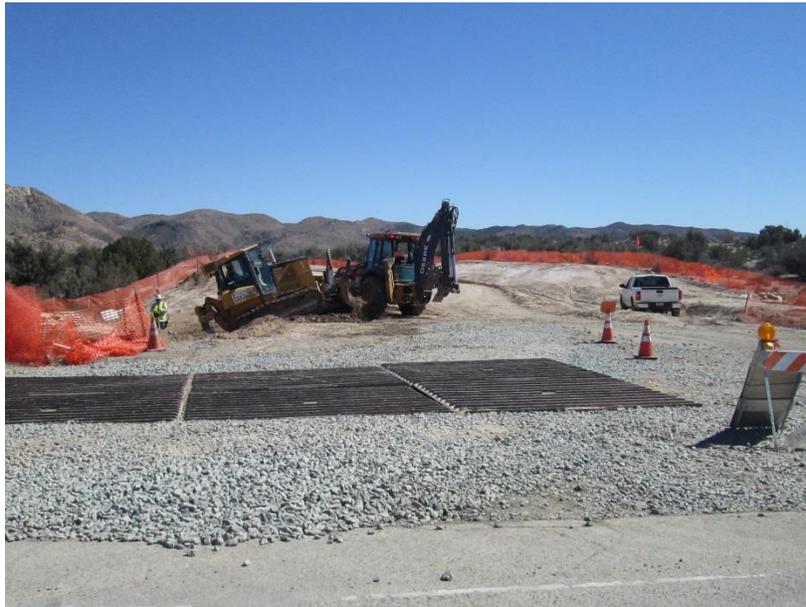
Photo 6: A rock apron and rattle plates are being maintained at the point of ingress/egress to the ECO substation in accordance with MM-AQ-1.
